District 3, Marion County

IDENTIFICATION	
(1) State Names	13-Georgia
(8) Structure Number	197-5022-0
(5) Inventory Route	00122
(2) Highway Agency District	3
(3) County Code	Marion
(4) Place Code	0

(6) Features Intersected	LANAHASSEE CREEK
(7) Facility Carried	BILL MERRITT ROAD
(9) Location	10.5 MI SE OF BUENA VISTA
(11) Mile Point	4 mi
(12) Base Highway Network	Yes

(115) Year of Future ADT	2031
INSPECTIONS	
(90) Inspection Date	04/2019
(91) Frequency	24 Months
(92) Critical Feature Inspection	Done Freq. (Mon) Date
A: Fracture Critical Detail	No
B: Underwater Inspection	No
C: Other Special Inspection	No

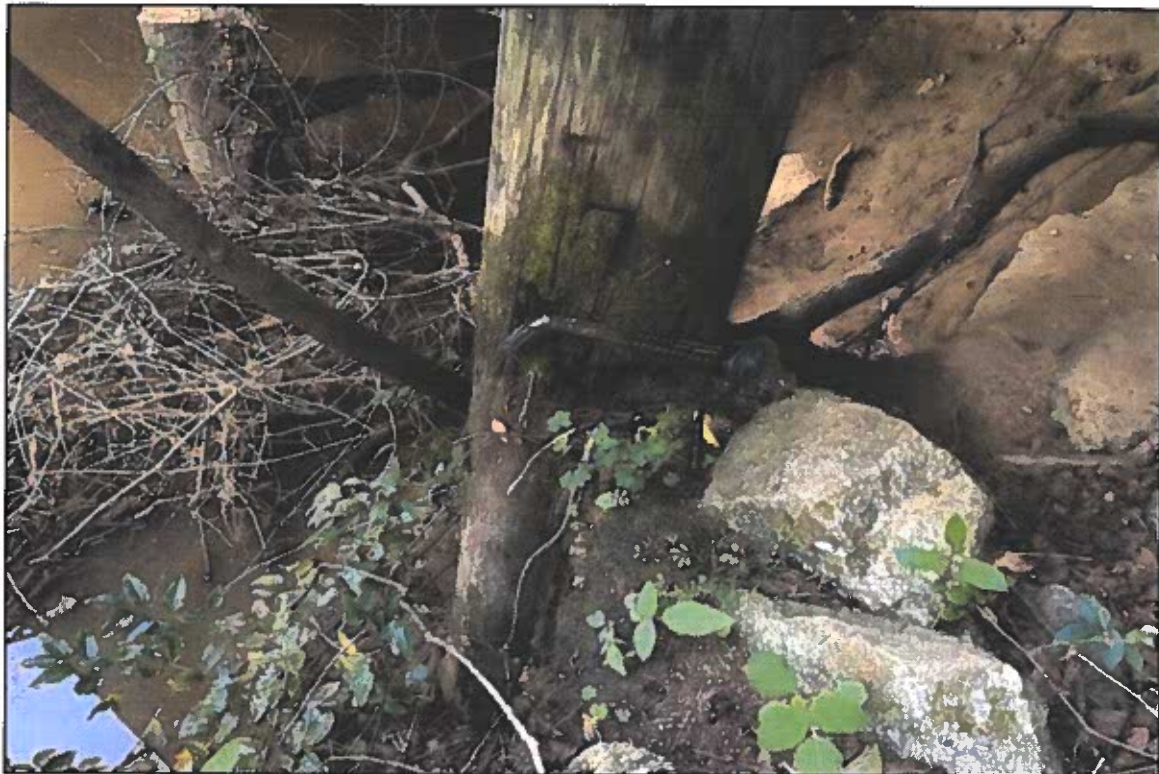
Pile 1 at bent 2 is 100% rotten.

Pile 1, bent 2 is 100% rotten

Activity	Priority	Location	Comments
520-Brush and Tree Cutting	C	Both sides	cut and remove
800-Bridge Joint Sealing	C	all joints	clean and seal
845-Other Bridge Maintenance	B	upstream	remove beaver dam
000-Bridge Painting	C	all beams	clean and paint
825-Pile Replacement	B	Pile 1, bent 2 and pile 1, bent 3

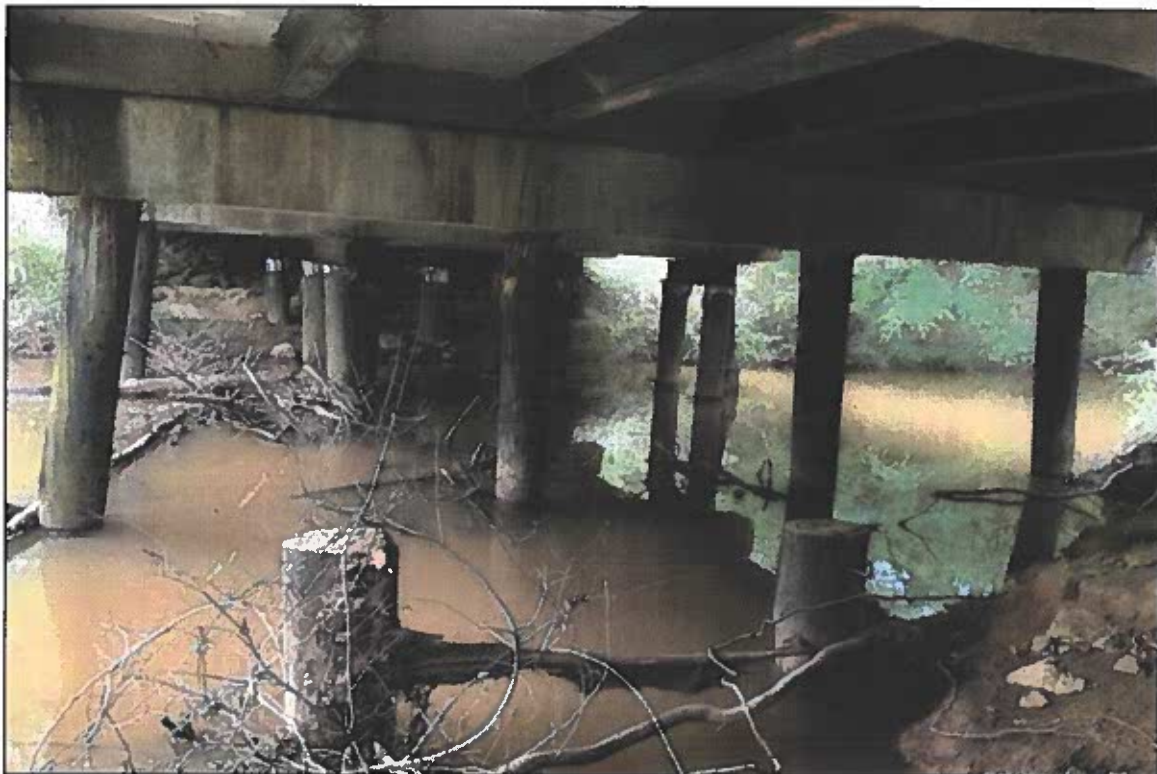
Superstructure

Paint is peeling and flaking on all beams.
Minor corrosion on bottom flanges.
